HRI Project 1666

EVALUATION OF SAFEGUARDS  
AT THE CYANIDE LEACH OPERATION  
RICO, COLORADO

Crystal Oil Company  
P. O. Box 1101  
Shreveport, Louisiana 71163

June 11, 1975

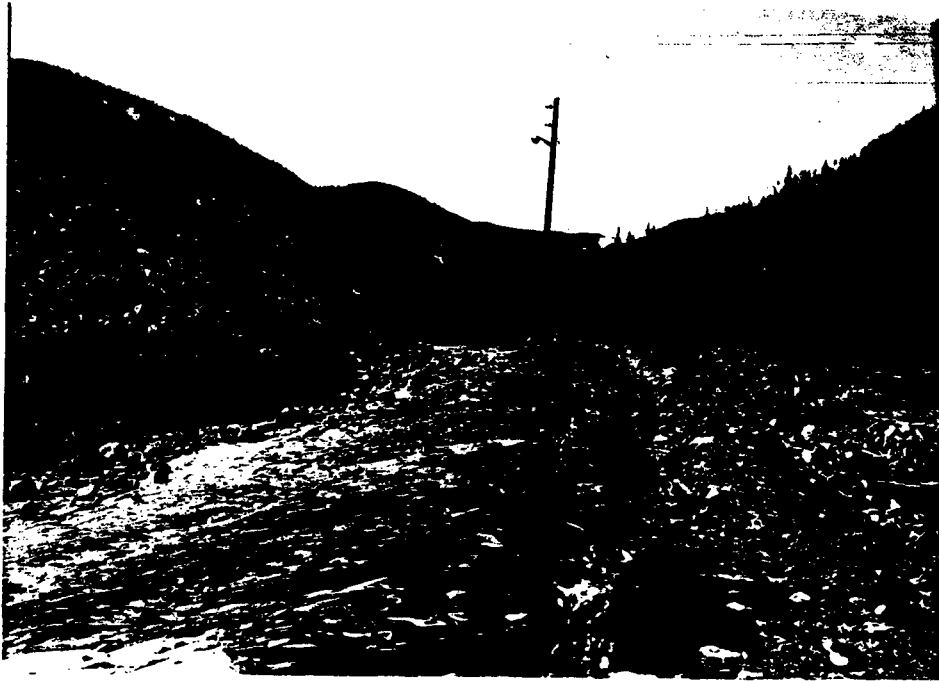
Downstream view of Hypalon-lined moat on west side of leach heap. Note light fixture on pole.

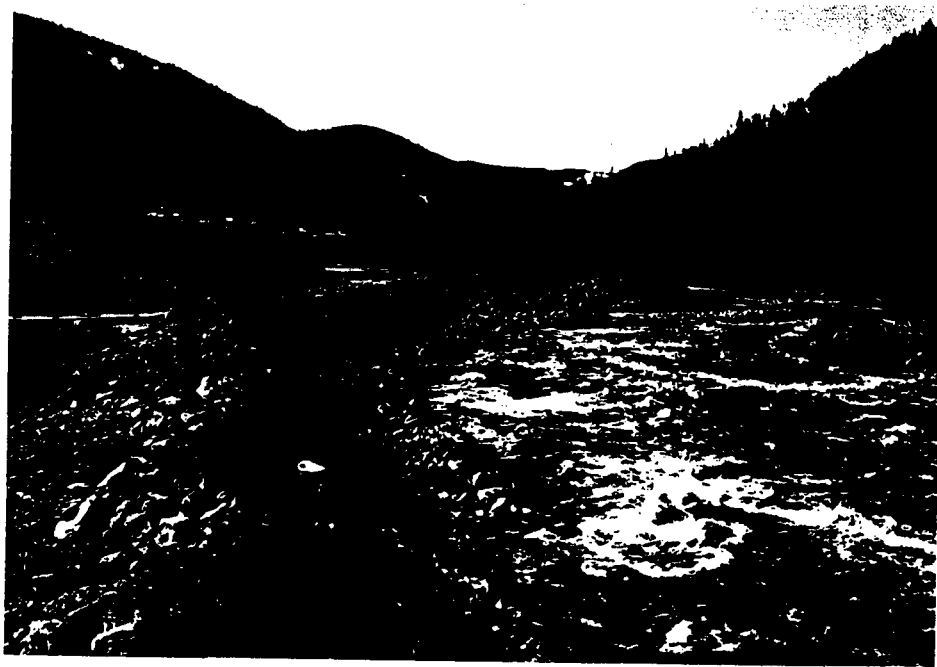
Face of berm and rip rap on west side of heap area. Spring runoff is causing heavy flow in Dolores River. Peak flow at the time, June 4, 1975, was recorded at 1,580 cfs (711,000 gpm) at the gage below Rico. Maximum daily rate in 1972 was 660 cfs, in 1973, 1,620 cfs, and in 1974, 783 cfs.

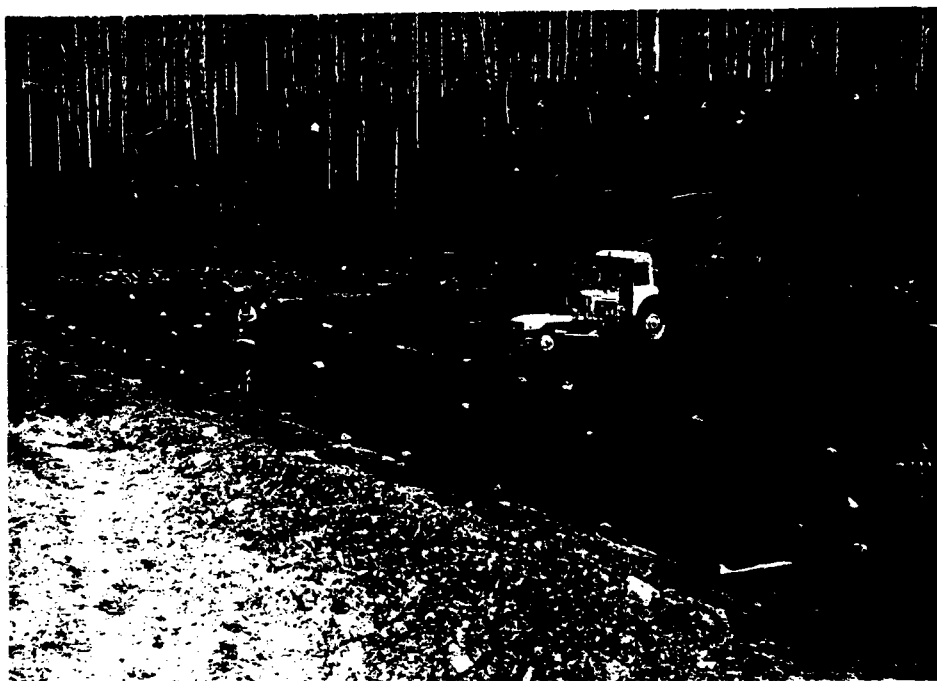
Hypalon sheet being laid for the base of the new heap to be constructed.

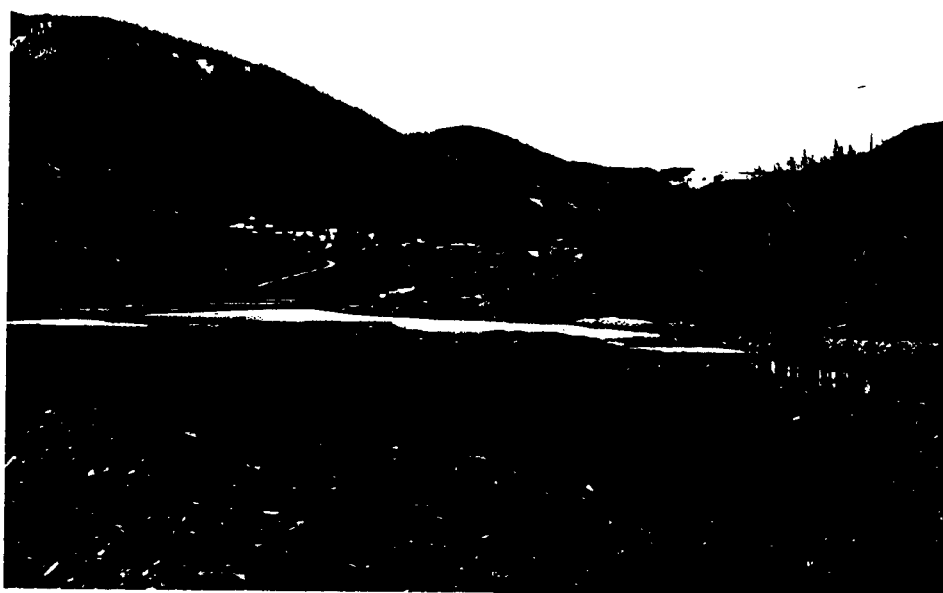
Downstream view of calcine pond in foreground and the string of clarification ponds containing St. Louis Tunnel effluent. Ponds are separated from the river by the levee in the background.
